# Grandfather's House

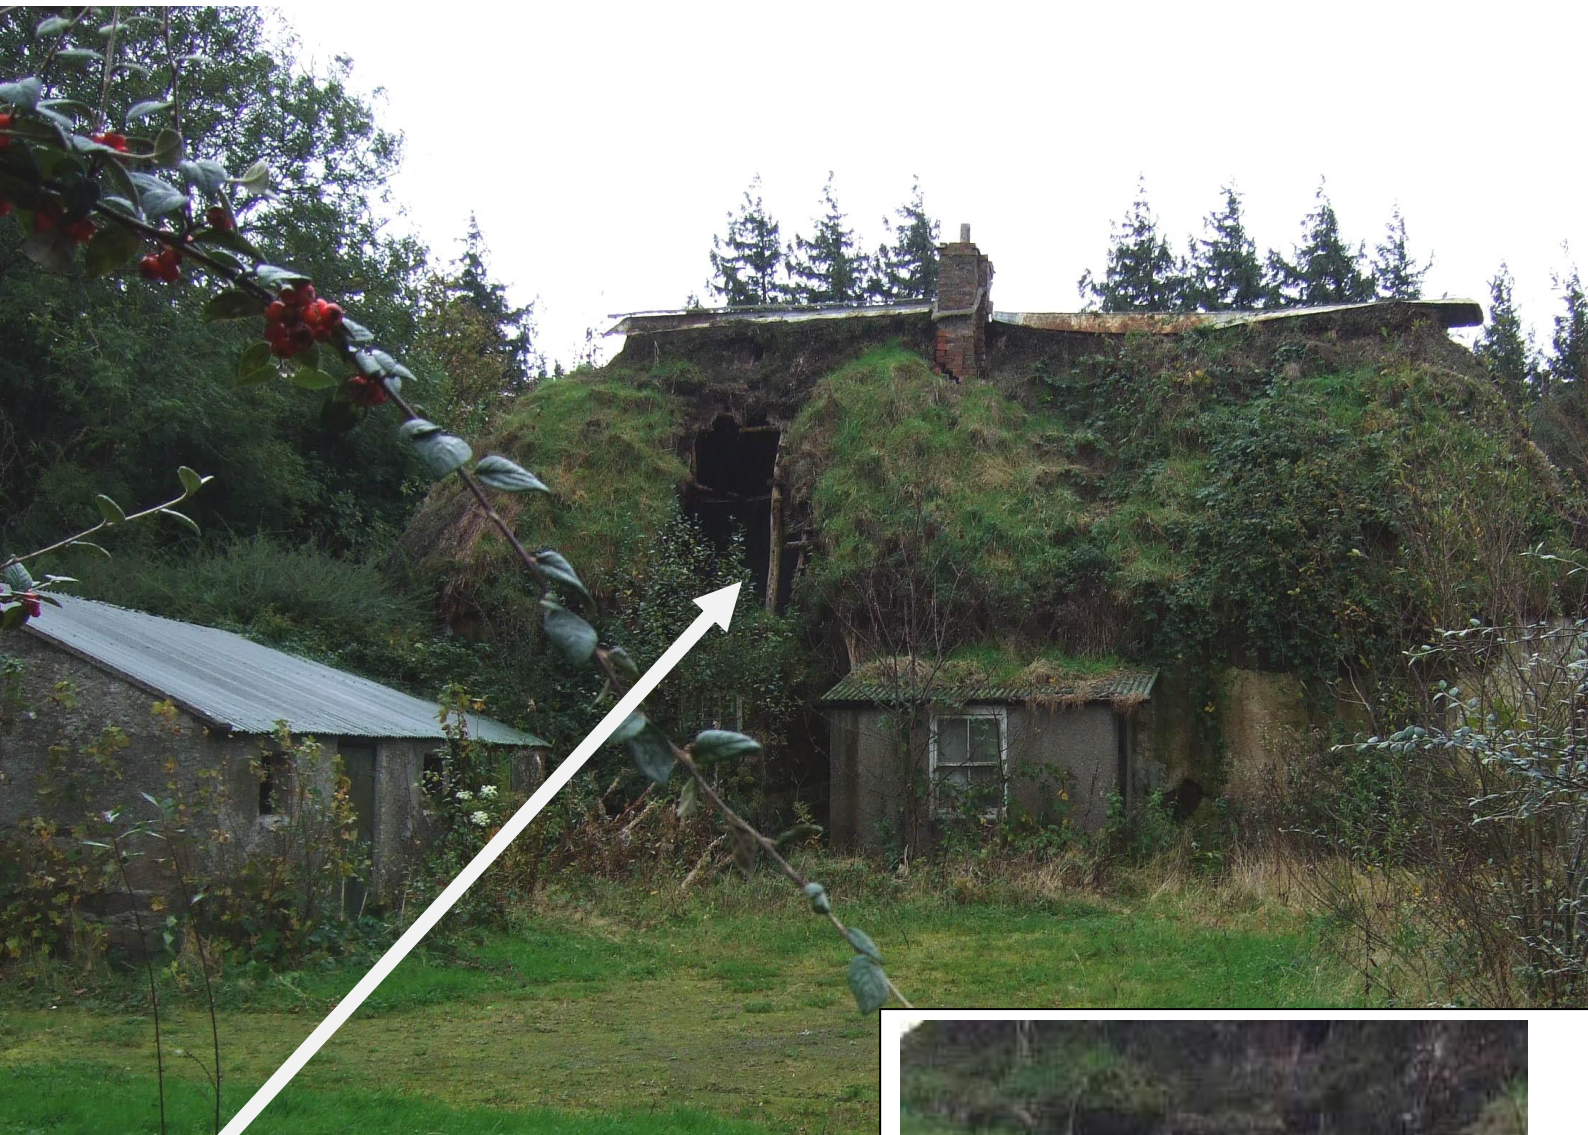
A closer look will let you see that this 2-storey house was structured around a framework of upright rough-cut branches which extended from the ground up to the top of the second floor. The ridge itself is of corrugated iron sheeting but a considerable amount of the thatch has slipped down from the ridge.

The entire building is in very unstable condition at the moment (November 2007) . I imagine that in another year the roof will be gone completely – so too will the evidence of the 2-storey wooden (large branches or young trees) uprights around which the mud walls of this high building were constructed.
